**State of Louisiana
Office of Coastal Protection and
Restoration**

2011 Annual Inspection Report

**GIWW/ CLOVELLY HYDROLOGIC
RESTORATION**

State Project Number BA-02
Priority Project List 1

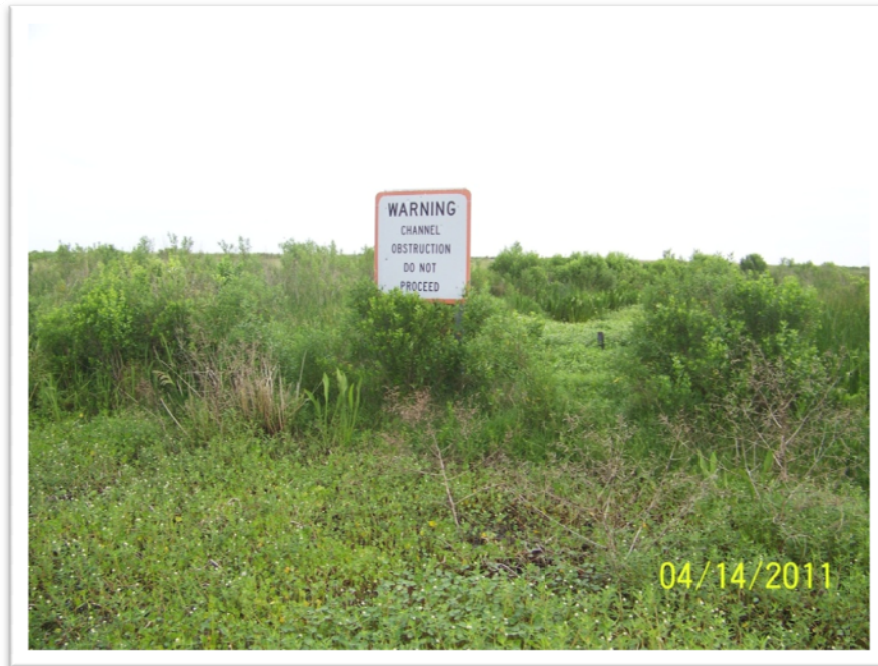
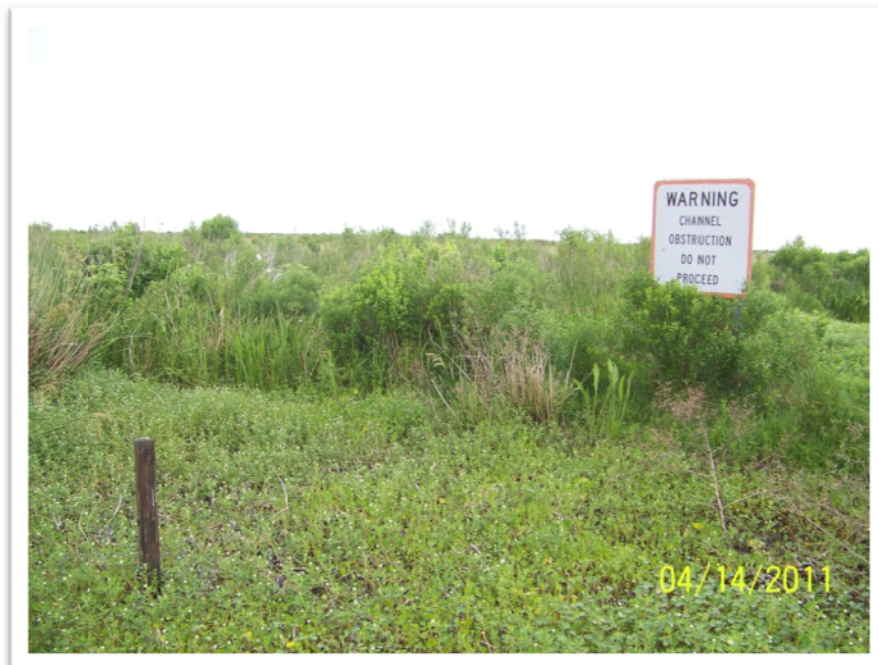
We were unable to visually inspect Structure 43 due to it being completely overgrown with vegetation. It was previously reported there was a shallow depression approximately 5 to 7 feet wide in the rock embankment on the east side of the plug, but it did not appear the depression has increased in width or depth. It is possible that water may by-pass the plug as the crest of the structure is only slightly above the existing marsh elevation, but there was no evidence of this during the inspection. All warning signs and support structures appear to be in good condition, and at this time, there are no recommendations for maintenance. (Appendix B, Photos No.1 through No.2)

Photo 1: Structure 43 rock channel plug is completely overgrown with vegetation, looking north

Photo 2: Structure 43 rock channel plug is completely overgrown with vegetation, looking north

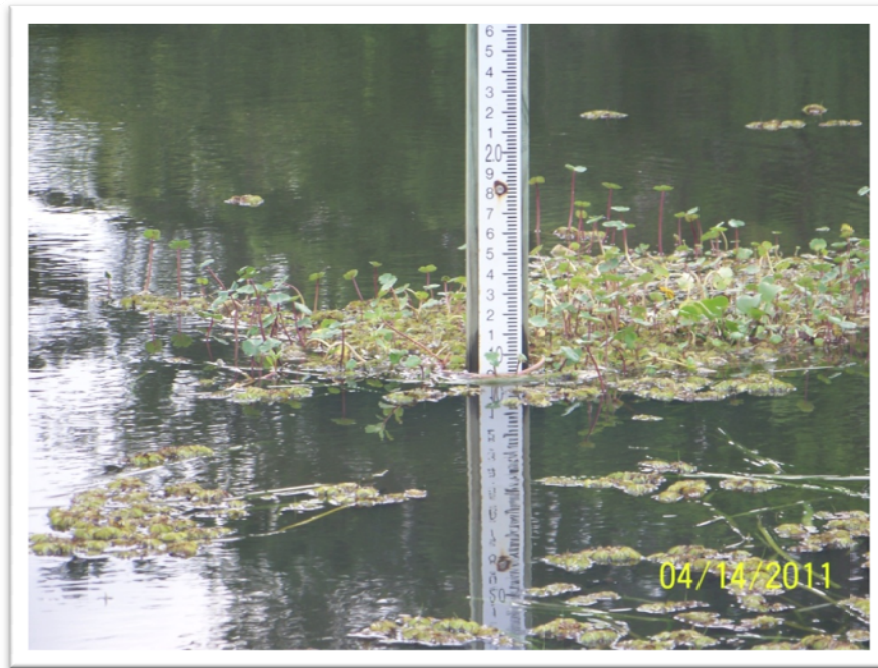
Photo 3: Gage (BA-02-57) is located along Superior Canal north of Structure No.1

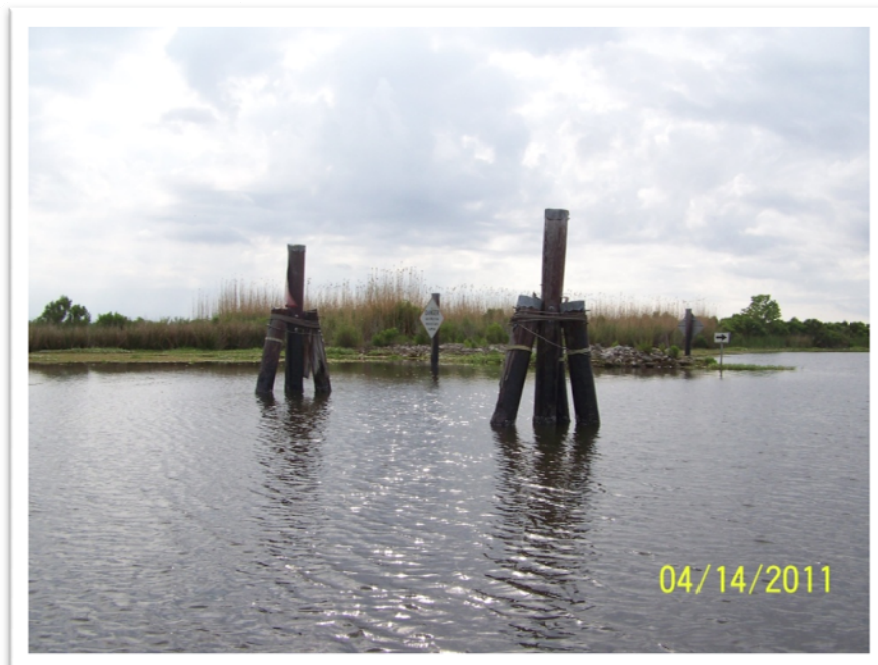
Structure 1 appeared to be in good overall condition with no observable settlement or displacement of the rock riprap material. According to the as-built drawings, the weir was constructed to a height of -6.4' NAVD at the barge bay and +4.0' NAVD along the crest on both sides of the weir between the barge bay and bank line. At 9:15 AM, the staff gauge reading from the CRMS station just north of Structure 1 was recorded to be 0.9' NAVD., and the water depth in the barge bay was recorded at 6.5'. As previously reported, there is considerable damage to the four (4) timber pile dolphins at the entrance of the barge bay. This damage is believed to be caused by oilfield service barges accessing the opening. The damage includes the vertical piles splitting, piles displace from original position, scarring on the surface of the piles, and the complete destruction of one of the four dolphin structures. Due to the poor condition of the timber dolphins, we have included provisions in the 2010 maintenance project to replace all four (4) dolphin structures. Also, as a preventative measure, we are recommending the structures be relocated approximately 6" further apart towards the bank to allow barges to move more freely through the barge bay without damaging the timber pile dolphins. A summary of proposed maintenance included in the 2010 Maintenance Project for Structure 1 are outlined in the conclusion of this report. (Appendix B, Photos No. 4 through No. 6)

The deficiencies at Structure No.1 were limited to the four (4) timber cluster piles near the entrance of the barge bay. The timber structure on the southwest side of the barge bay was completely destroyed and no longer exists, the remaining three (3) cluster piles were severely damaged with large splits down the middle of the piles, the batter piles were off center and the surface of all the timbers were worn or scarred from marine vessels rubbing the timbers while accessing the barge bay. Under the 2010 Maintenance Project, all four (4) timber pile clusters will be removed and replaced with new material including hardware, cables and signage. With concurrence from NRCS, we are also recommending that the new structures be relocated slightly outwards (6" to 1'), towards the bank, to allow for additional clearance for barge vessels to move through the barge opening without interference.

Photo 4: Structure 1 damaged timber dolphin structures, looking south

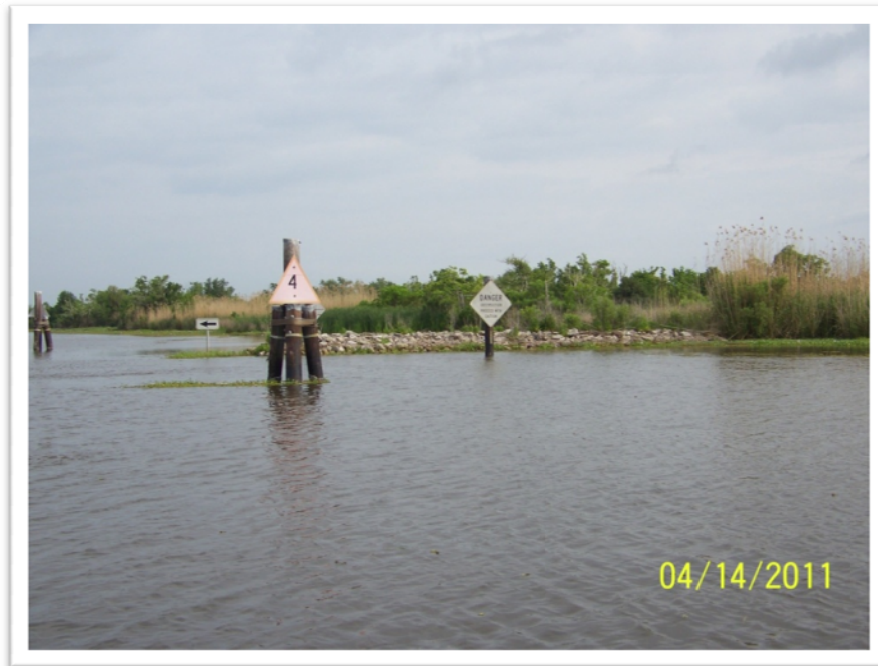
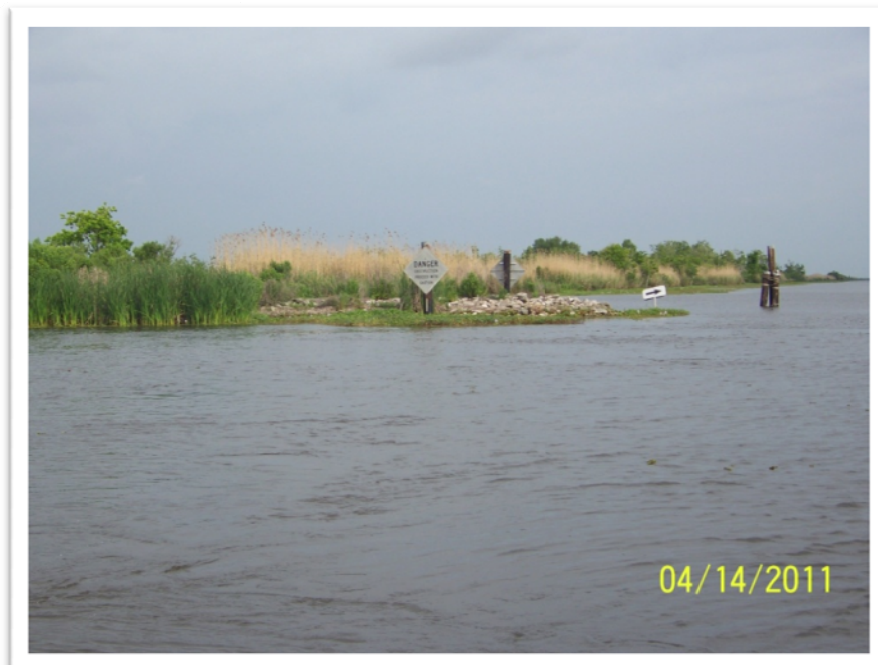
Photo 5: Structure 1 fixed crest rock weir shoreline tie-in on east side, looking north

Photo 6: Structure 1 fixed crest rock weir shoreline tie-in on west side, looking north

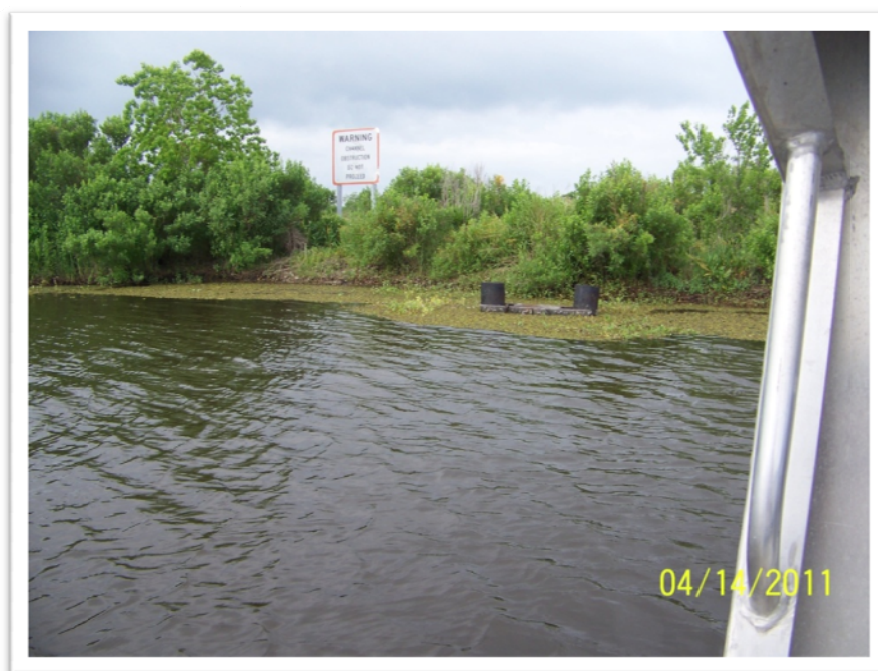
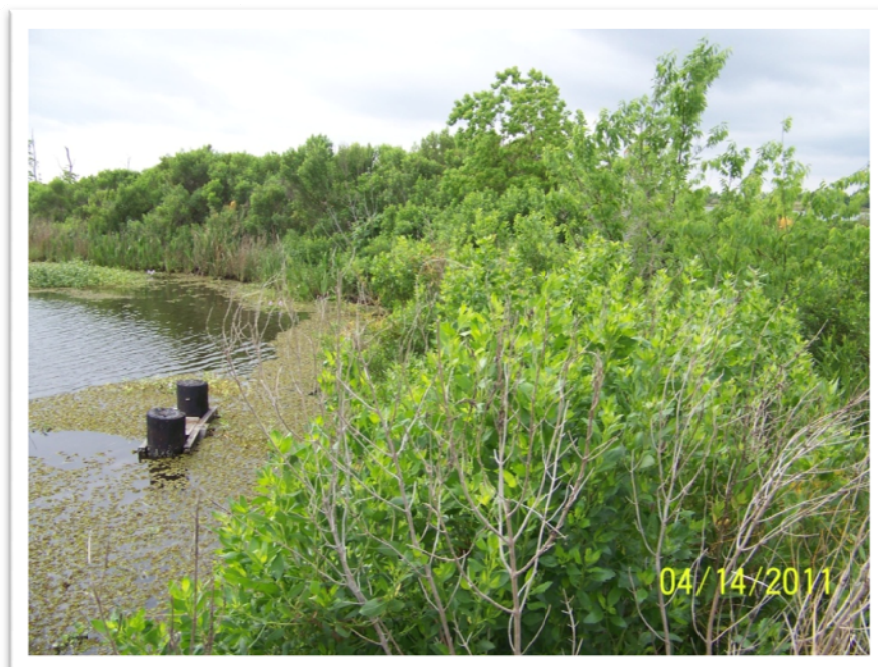
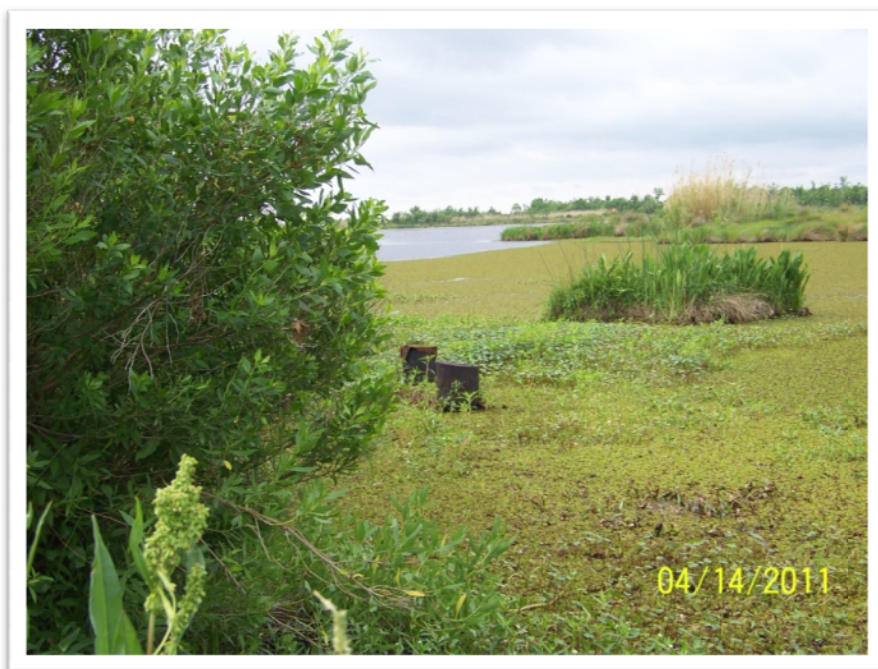
Structure 91 rock plug structure appeared to be in good condition without any signs of rock settlement or erosion around bank tie-ins. The warning signs and timber supports were also in good overall condition. As previously noted, the sheet metal covering the timber piles supporting the corrugated metal pipe are rusted and corroded. To prevent these timbers from

rotting, the replacement of the sheet metal cap is included in the 2010 maintenance project. At the time of inspection, we were unable to operate the flap gate due to excess vegetation surrounding the gate. As part of the 2010 Maintenance Project the gate be removed, inspected, and cleaned if needed. (Appendix B, Photos No.7 through No.9)

The rock plug was in good condition with no obvious settlement or erosion around the bank tie-ins. However, we did identify minor maintenance which included severe corrosion of the metal caps covering the butts of the timber piles supporting the culvert and flap gate. To prevent rotting of the heads of the timber piles the metal sheeting on the top the timber piles will be replaced. As preventative maintenance, we will also be removing the flap gate attached to the culvert for inspection and cleaning, if required.

Photo 7: Structure 91 rock plug with flap gate overgrown with vegetation view from canal, looking south

Photo 8: Structure 91 rock plug with flap gate view from structure, looking east

Photo 9: Structure 91 rock plug with flap gate view from inside impoundment area, looking south

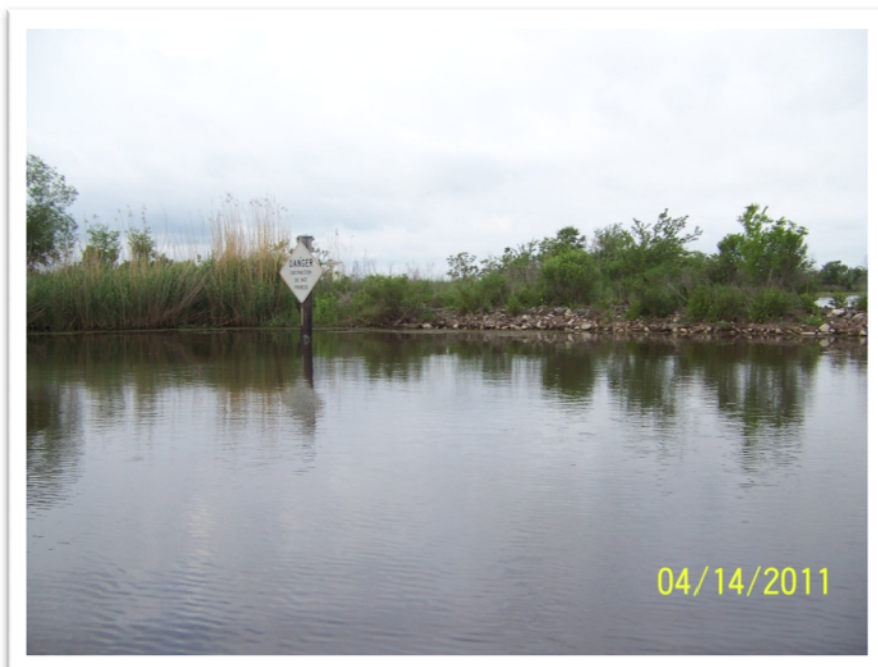
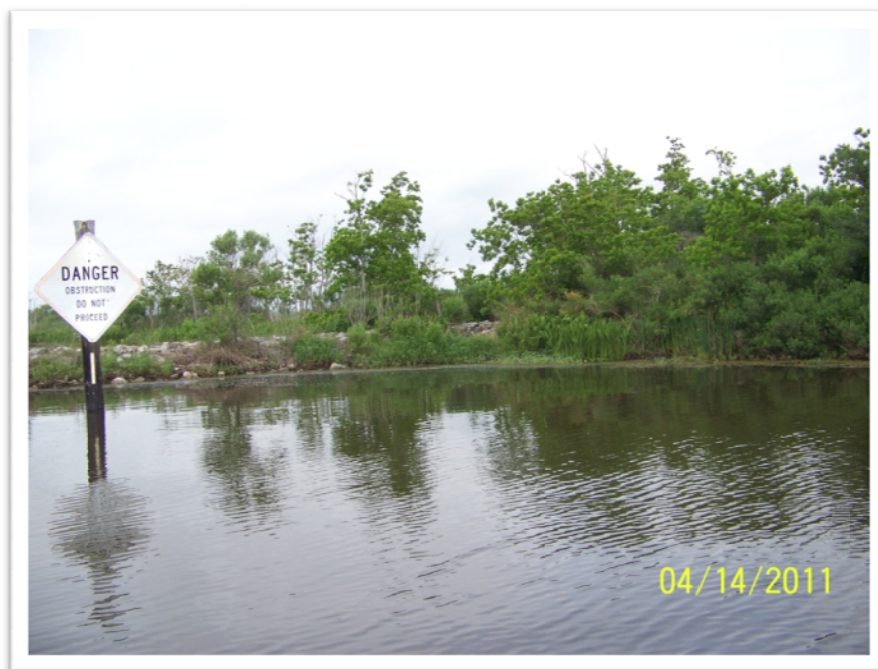
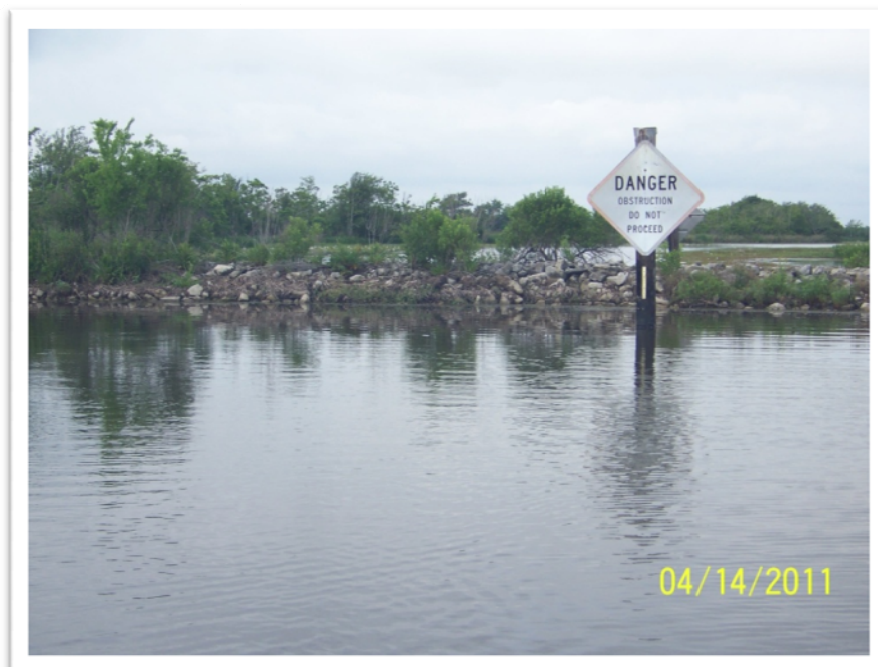
Structure 90 appears to be in overall good condition with no rock settlement/ displacement or erosion around the embankment tie-ins. All warning signs and supports are in good condition also. There are no recommended corrective actions at this time. (Appendix B, Photos No. 10 through No. 12)

Photo 10: Structure 90 rock channel plug bank tie-in on south side of structure, looking west

Photo 11: Structure 90 rock channel plug bank tie-in on north side of structure, looking west

Photo 12: Structure 90 rock channel plug and timber warning sign, looking west

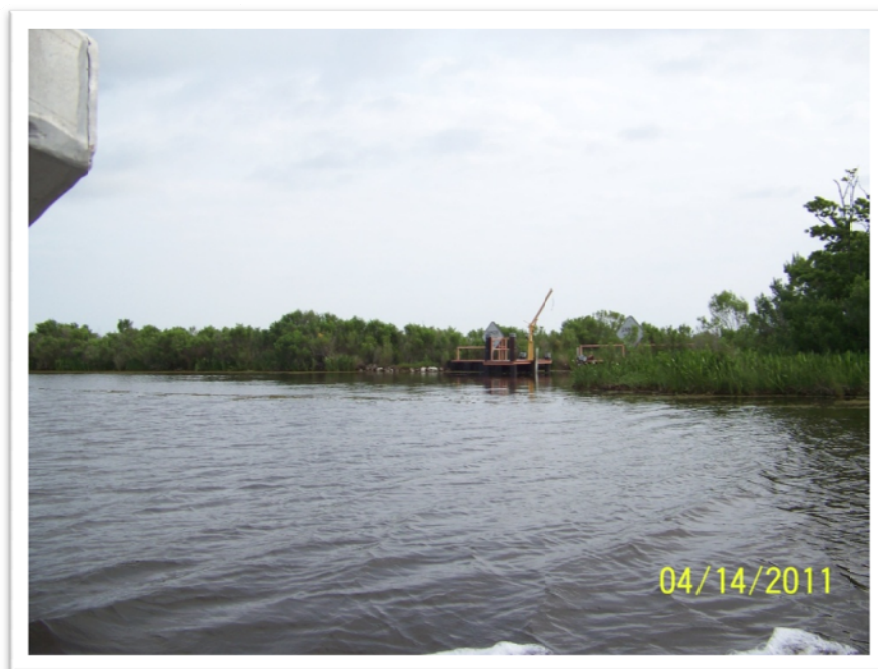
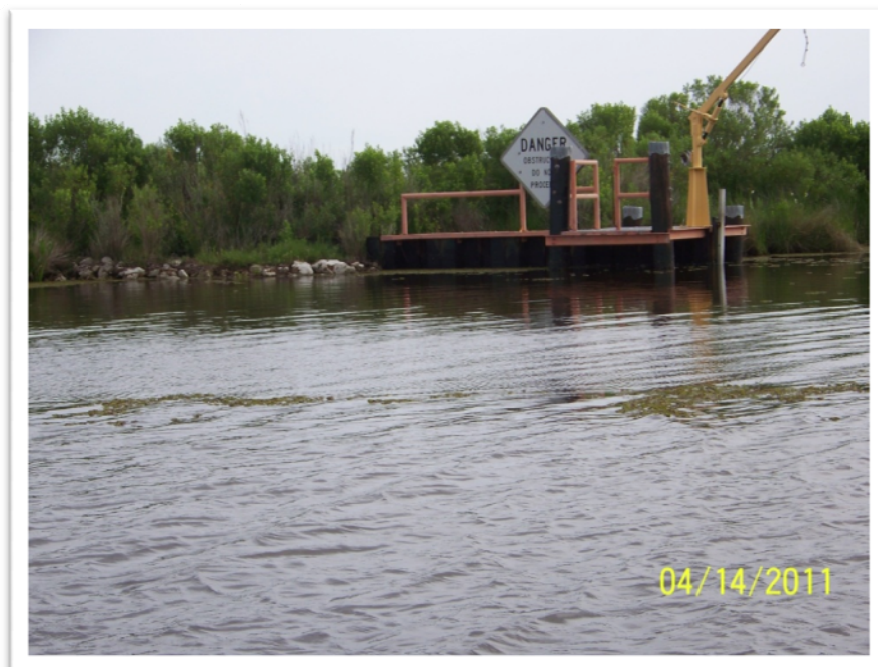
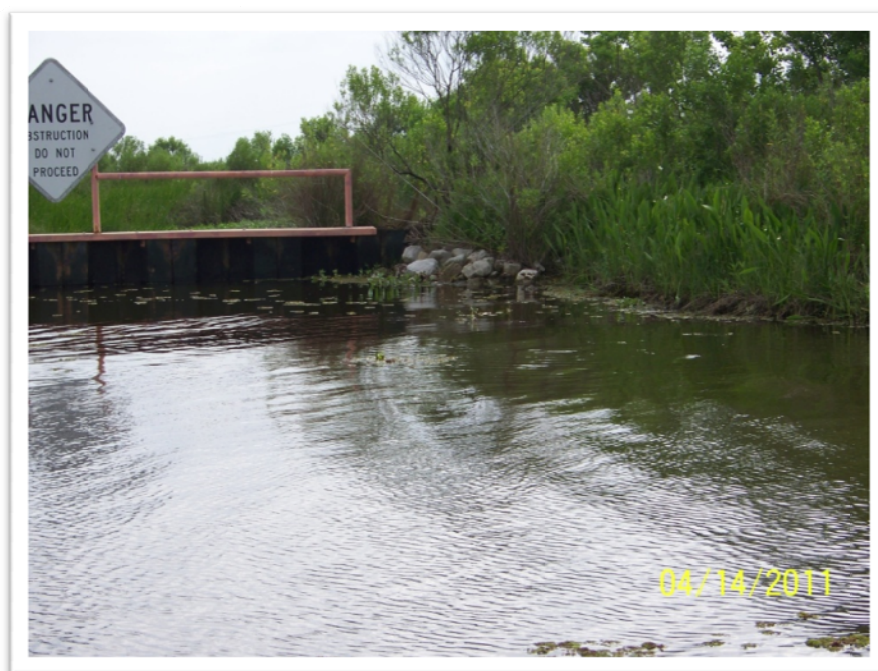
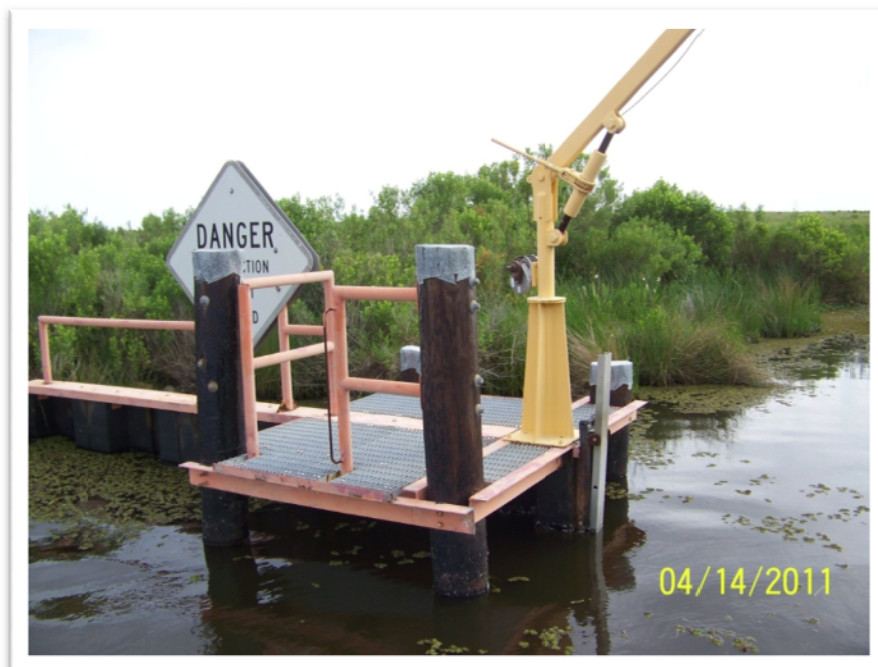
Structure 35 is in overall good condition with some signs of minor corrosion on the bulkhead cap, handrails and deck. The stop logs, cables, signs and supports appear to be in good condition and operable. At the time of inspection the channel from the weir to the interior marsh was open and there appeared to be adequate flow through the interior marsh and structure. The embankment tie-ins also appear to be in good condition with no erosion or washouts. We are not recommending any repairs or corrective actions at this time. (Appendix B, Photos No.13 through No.16)

Photo 13: Structure 35 variable crest weir water control structure, looking west

Photo 14: Structure 35 variable crest weir bank tie in on north side, looking west

Photo 15: Structure 35 variable crest weir bank tie in on south side, looking west

Photo 16: Structure 35 variable crest weir close up view, looking west

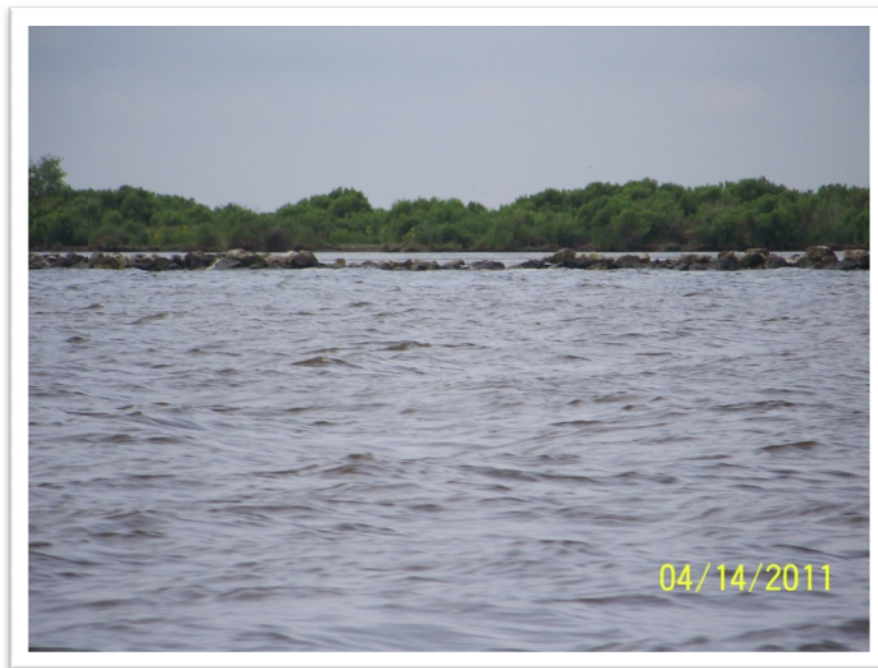
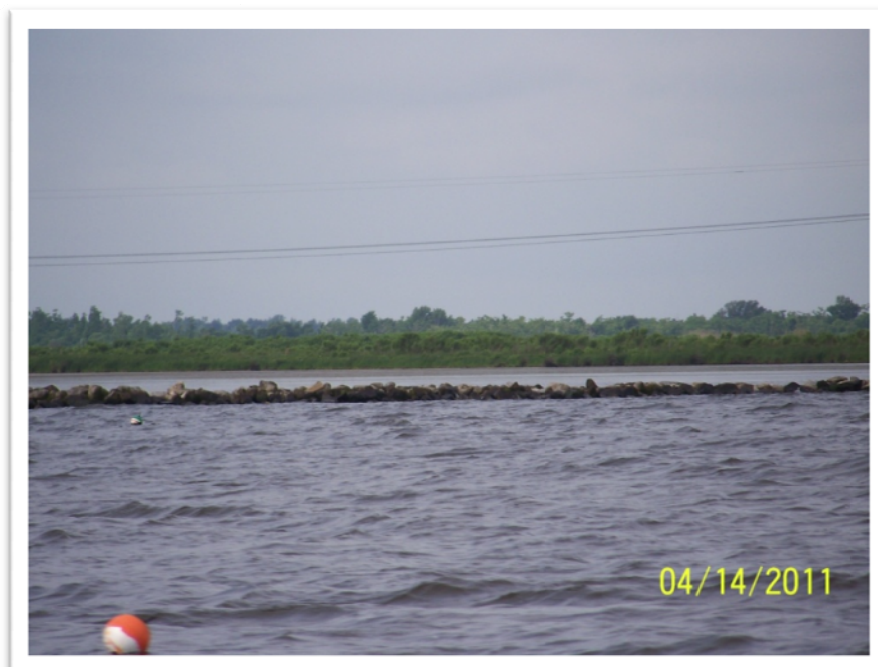
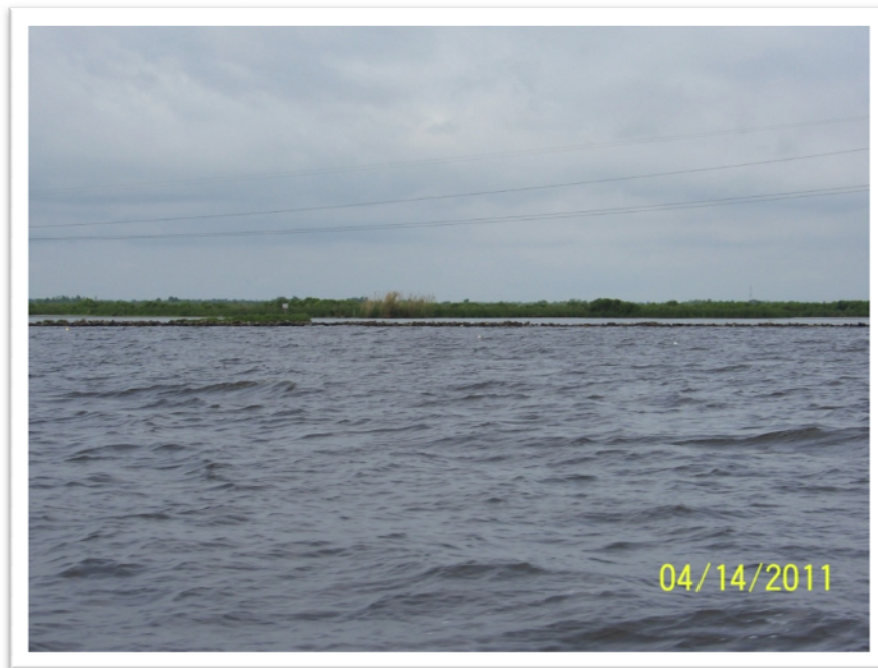
The lake rim structure was constructed between a +2.0' and +3.0' NAVD with six (6) fish dips at various locations along the structure. As indicated on previous inspections and surveys, the rock dike has displayed minor to moderate settlement along the entire length of the structure. The most notable segments include segments between Stations 7+00 and 13+00, 36+00 and 41+00, and the intersection near the mouth of Breton Canal. During the 2010 field inspections, we observed additional low areas along the north bank of Breton Canal from the mouth of Bay L' Ours proceeding southwest to the first oilfield location canal where Structure 35 is located. Based on the current condition of rock dike, we have included provisions in the 2010 Maintenance Project to reconstruct the entire length of the lake rim, including the Breton Canal reach, to the original design elevation. (Appendix B: Photo No.19 through 17)

Photo 17: Rock dike shoreline protection on west side of Bay L'Ours in Little Lake, looking west

Photo 18: Rock dike shoreline protection on west side of Bay L'Ours in Little Lake, looking west

Photo 19: Rock dike shoreline protection on west side of Bay L'Ours in Little Lake, looking west

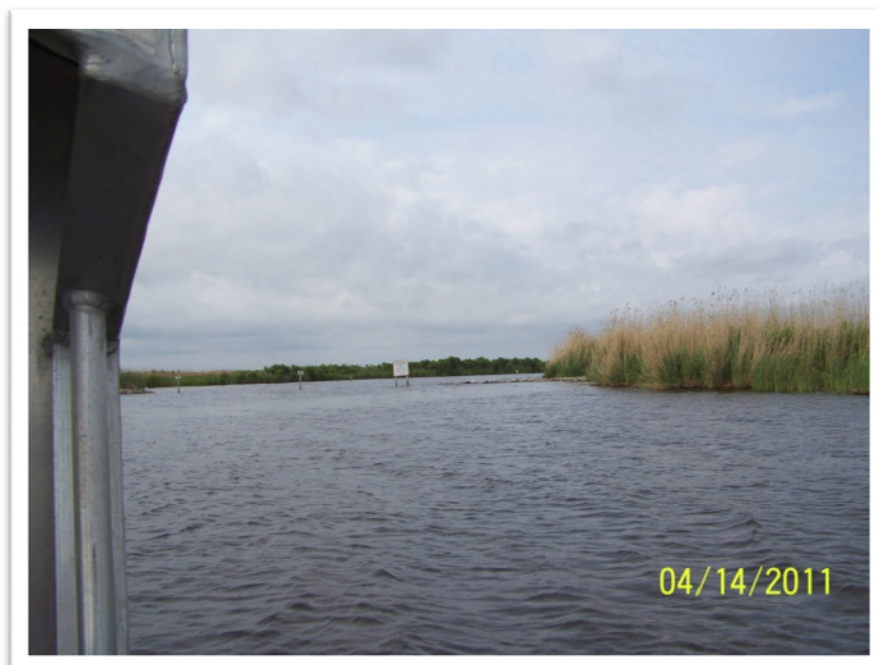
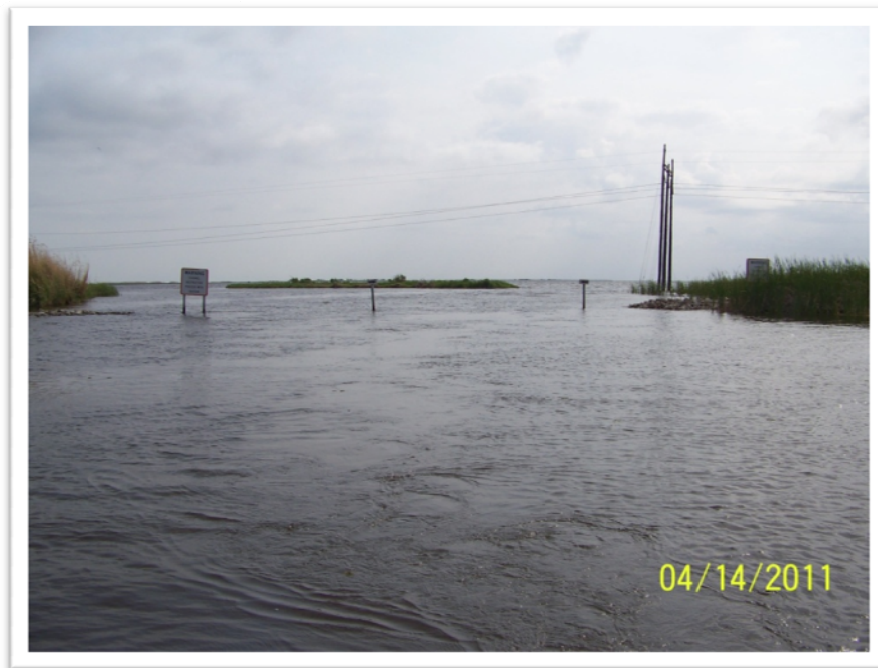
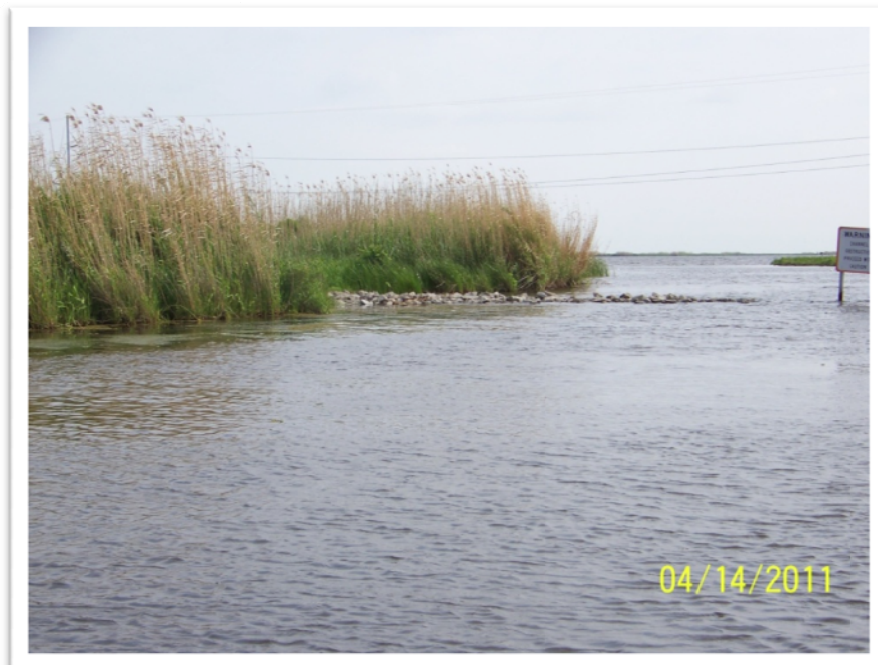
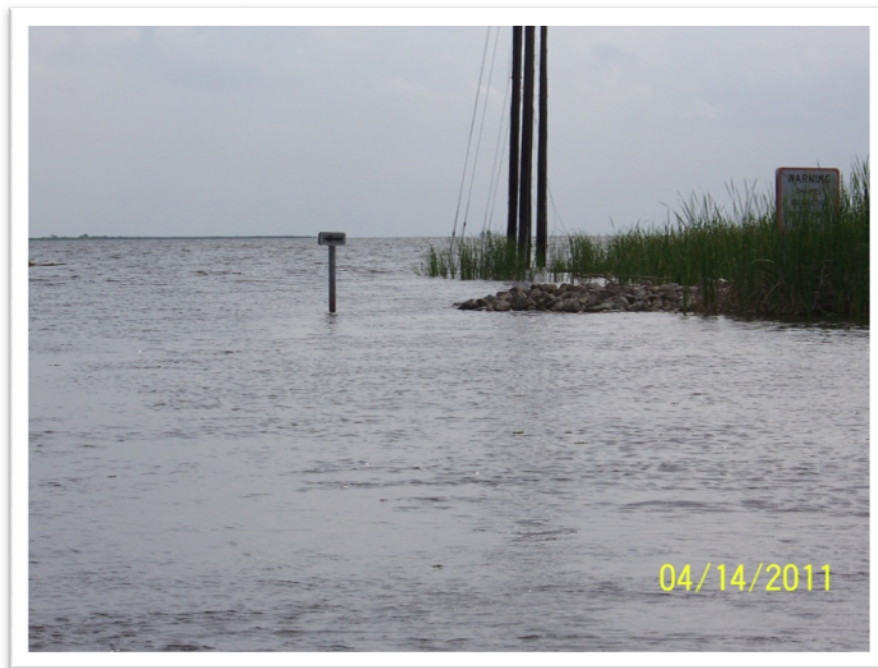
Structure 2 is a three (3) level fixed crest weir constructed of rock riprap material. According to the as-built drawings, the sill elevation closest to the bank was constructed to an elevation of +3.9' NAVD, the section between the bank and the boat bay was constructed to +2.3' NAVD, and the boat bay was constructed to -5.1' NAVD. At the time of the inspection, the water depth in the boat bay was recorded to be 7.2' from the surface. As previously reported, there was some moderate settlement observed between the bank and boat bay (approximately 1.3' to 1.5') and severe settlement observed in the boat bay (approximately 4' to 5'). Provisions for refurbishment of the rock weir under the 2010 Maintenance Project are outlined in the conclusions of this report. All warning signs and supports are in good condition and do not require maintenance at this time. (Appendix B, Photos No.20 through No.23)

The documented deficiencies at Structure No.2 were primarily due to settlement of the rock weir with the most severe settlement on the south side of the structure between the boat bay and existing bank. Under the 2010 Maintenance Project, the boat bay section and fixed crest sections be raised to the original design elevations using rock riprap. To facilitate repairs to Structure 2, access dredging from the lake to the structure may be required due to shallow conditions at the mouth of the channel.

Photo 20: Structure 2 fixed crest rock weir with boat bay, looking south west

Photo 21: Structure 2 fixed crest rock weir with boat bay, looking northeast

Photo 22: Structure 2 fixed crest rock weir bank tie-in on northwest side, looking northeast

Photo 23: Structure 2 fixed crest rock weir bank tie-in on southeast side, looking northeast

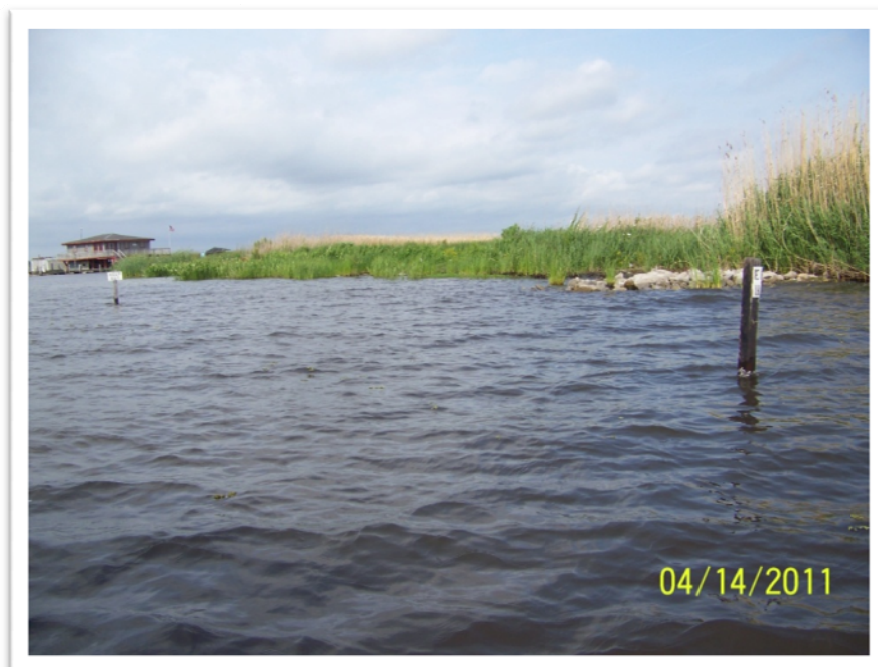
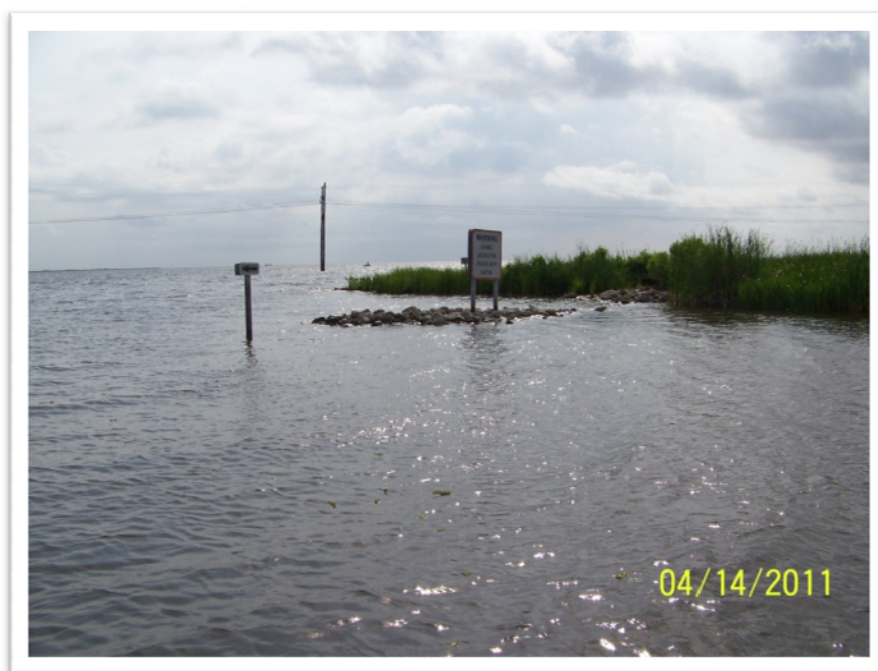
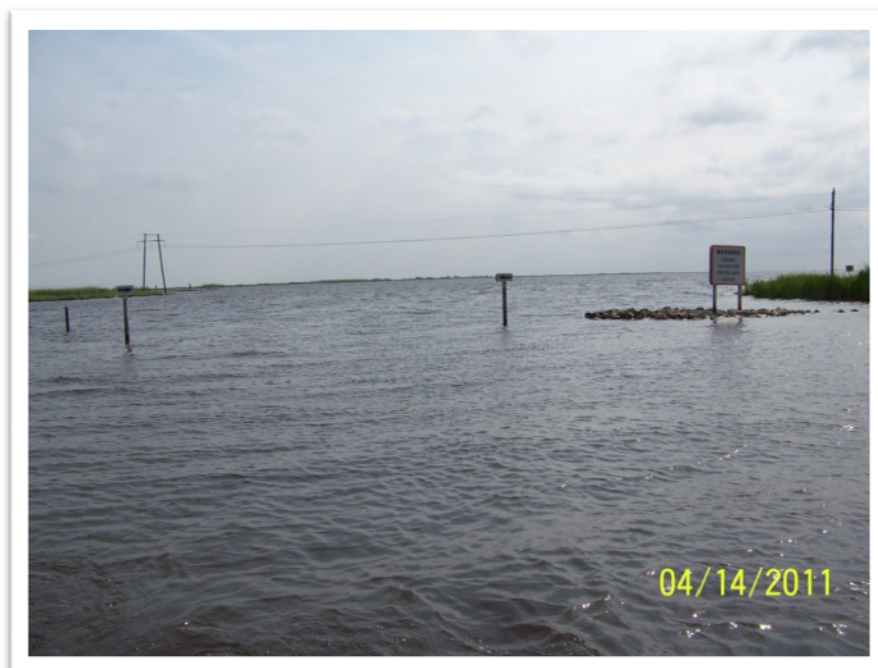
elevation of +3.8' NAVD, the section between the bank and the boat bay was constructed to +2.4' NAVD, and the boat bay was constructed to -3.9' NAVD. At the time of the inspection, the water depth in the boat bay was recorded to be 5.0' from the surface. As previously reported, there was some moderate settlement observed on the north side of the structure (approximately 1.5' to 2.0') and more severe settlement observed on the south side of the structure (approximately 6' to 7') including a breach on the south bank tie-in. Provisions for maintenance repairs and refurbishment of the rock weir are outlined in the conclusion of this report. The warning sign and supports on the north side of the structure are missing and recommended for replacement. (Appendix B, Photos No.24 through No.26)

Structure No.4 was found to be in fair to poor condition with severe settlement and/or displacement of the rock material on the south side of the structure and moderate settlement of the rock lining the boat bay and rock weir section on the north side. The warning sign on the north side of the structure was also missing. Under the upcoming 2010 Maintenance Project, Structure No. 4 will be refurbished with rock riprap to restore the structure to the original

Photo 24: Structure 4 fixed crest rock weir bank tie-in on north side of structure, looking west

Photo 25: Structure 4 fixed crest rock weir bank tie-in with low crest on south side of structure, looking east

Photo 26: Structure 4 fixed crest rock weir bank tie-in with low crest south side of structure, looking east

design elevation. The missing warning will also be replaced. As in the case of Structure No.2, access dredging from the bay to the structure may be required.

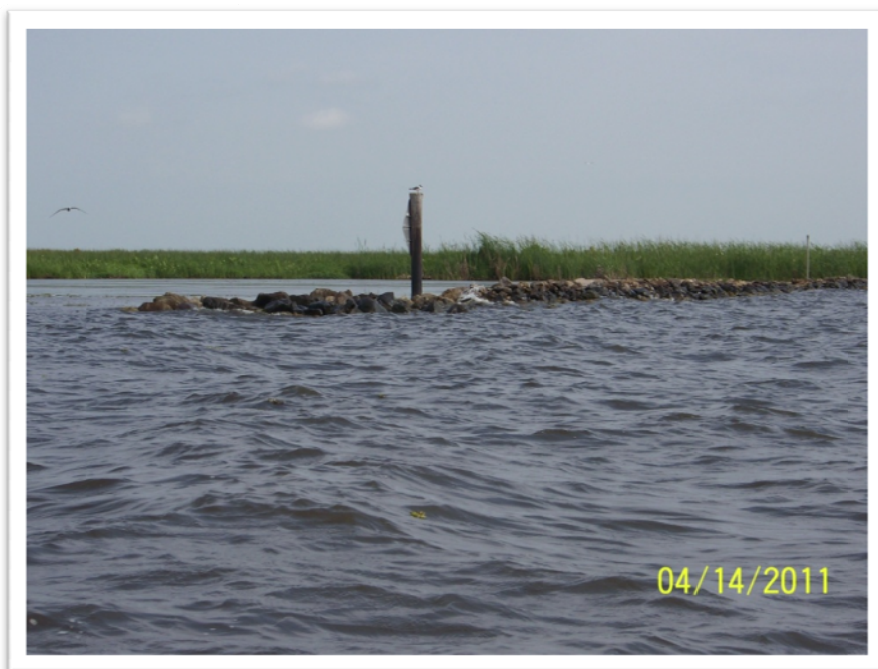
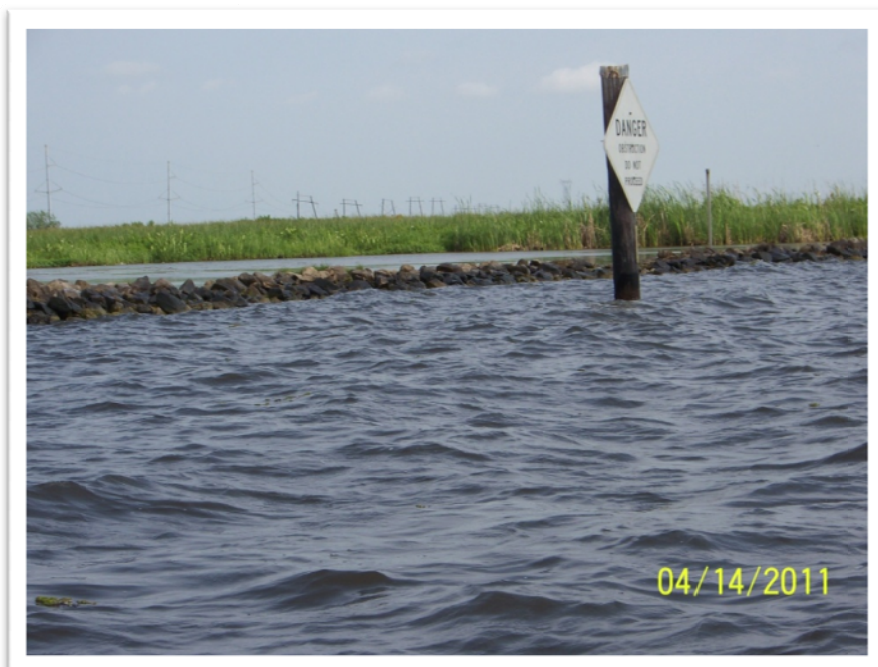
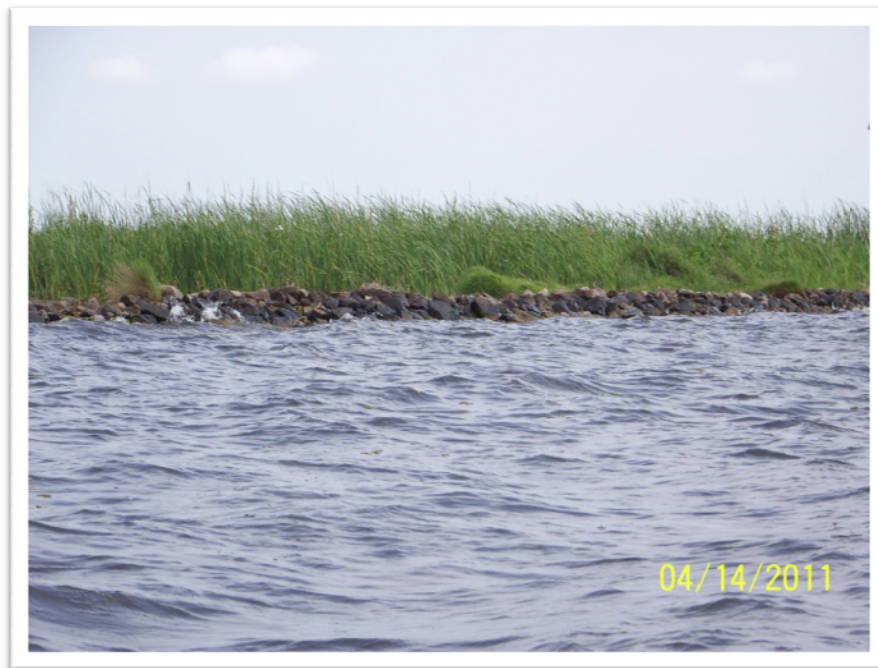
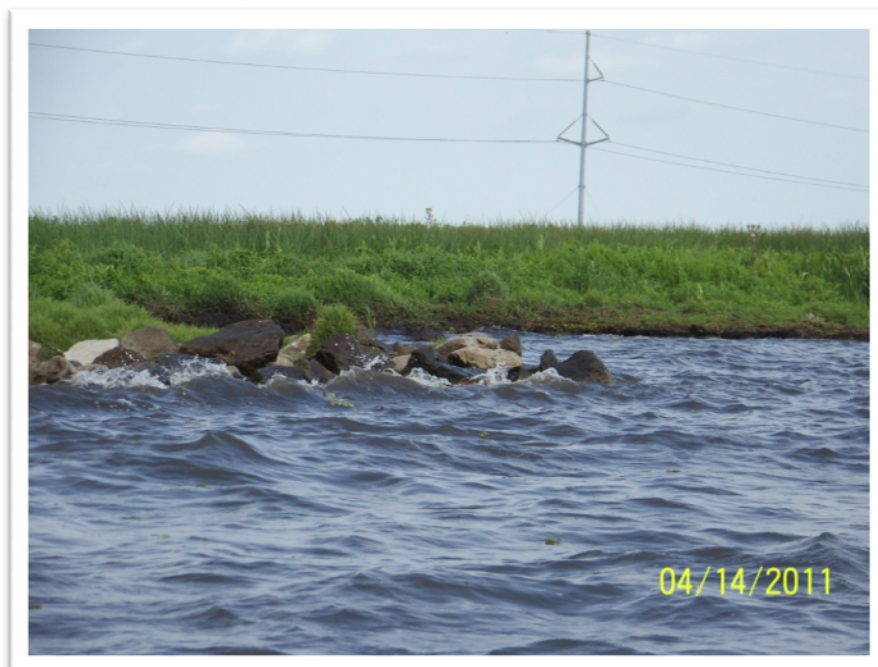
Structures 4A & 4B appear to be in poor condition with average crest elevations approximately +1.5' NAVD. According to the as-built drawings, the plug was originally constructed to a height of +3.0 NAVD. Based on these observations and supporting data from the 2008 survey profile, it is estimated the rock plug has settled approximately 1.5' to 2.0' along the entire length of the structure. In addition to the settlement, and partially caused by Hurricanes Gustav and Ike, the marsh around the plug has suffered extensive erosion. On the south side of the plug there is very large opening in the shore line approximately 1,000 feet wide. Due to the high cost of mobilizing a dredge to rebuild the marsh, it is more cost efficient to construct a rock dike across the opening. Provisions for maintenance repairs and construction of the breach closure are outlined in the conclusion of this report. (Appendix B, Photos No. 27 through No. 30)

The rock plug structures appeared to be in poor condition with substantial settlement ranging between 1.5' to 2.0'. The critical area of concern associated with this structure is large breach that has developed on the south side of the structure resulting from the 2008 storms. The marsh on the south side of the structure is completely gone with very little shoreline remaining to facilitate a breach closure by extending the structure. Considering the size of the breach and the vulnerability of the interior marsh in this area, we have included a rock dike closure in the 2010 Maintenance Project that consist of refurbishing Structures 4A & 4B to the original design elevation and extending the rock plug across the breach opening and along the existing shoreline approximately 1,500 linear feet, tying into Structure 4.

Photo 27: Structure 4B south side of rock channel plug, looking northwest

Photo 28: Structure 4B rock channel plug, looking northwest

Photo 29: Structure 4B rock channel plug, looking northwest

Photo 30: Structure 4B rock channel plug north bank tie-in, looking northwest

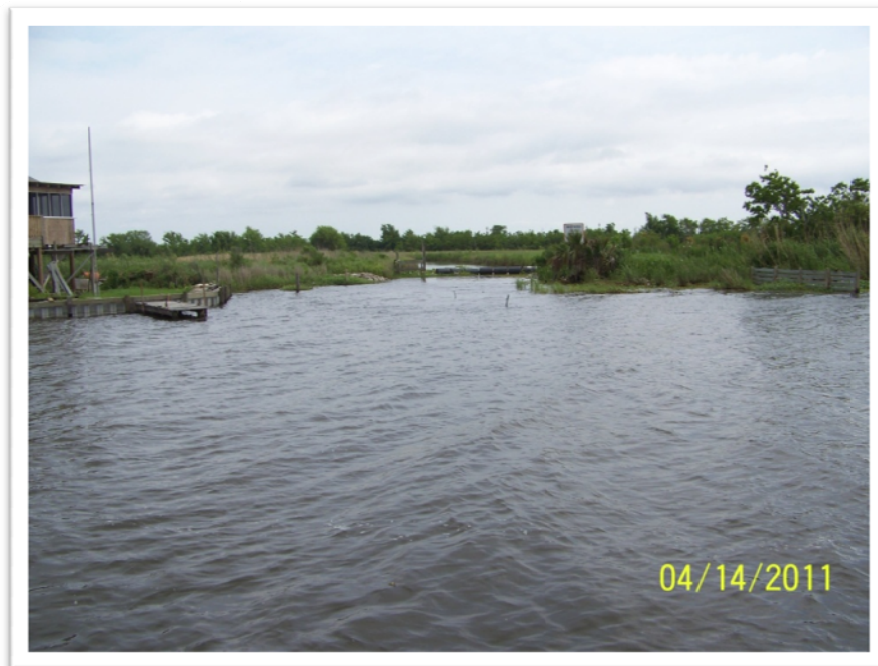
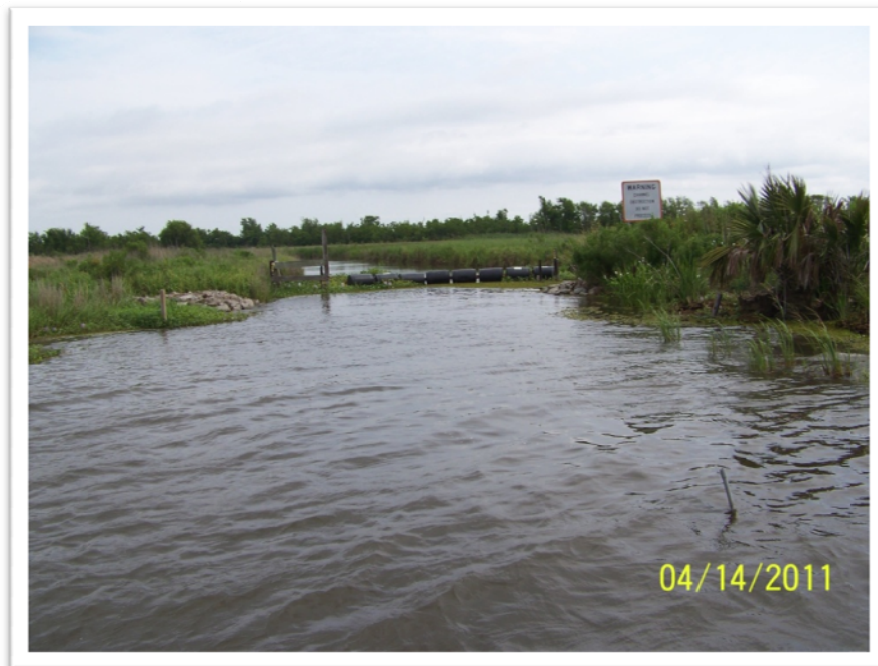
Structure 8 is a small rock weir with a boat bay located just north of Structure 7. This structure appears to be in fair condition with minimal settlement of the riprap material and no erosion or washouts around the bank tie-ins. This structure was originally constructed with a steel gate to prevent access into the interior marsh, but this gate was destroyed during Hurricanes Gustav and Ike. Since the gate was destroyed, the landowner has installed a series of floating barrels to restrict access, thus there is no need to replace the gate at this time. (Appendix B, Photos No.31 and No.35)

Photo 31: Structure 8 fixed crest rock weir with boat bay, looking north

Photo 35: Structure 8 fixed crest rock weir with boat bay, looking north
